City of Kingston
Report to Kingston Heritage Properties Committee
Report Number HP-24-030

Subject: Application for Ontario Heritage Act Approval

Address: 81 Gore Street (P18-938)

File Number: P18-051-2024

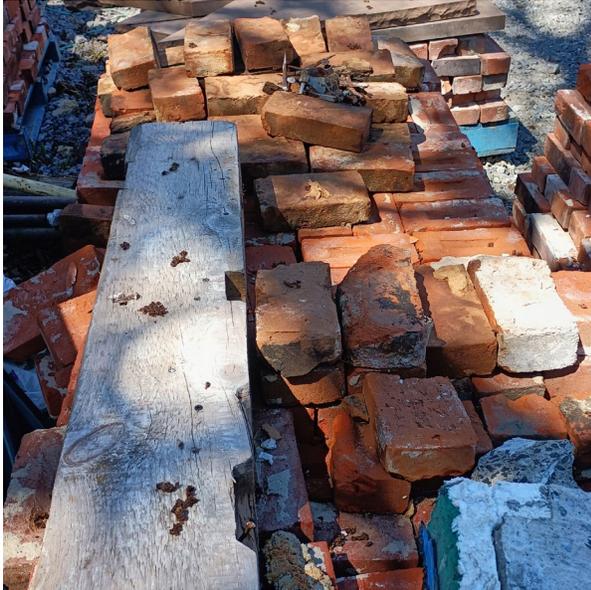
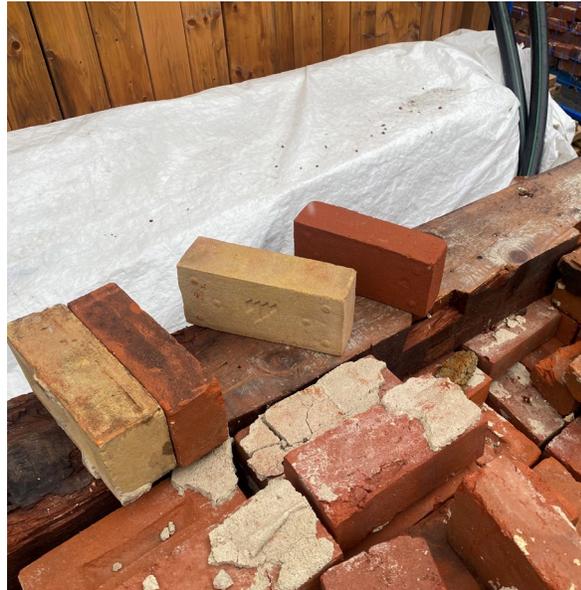
- A number being cracked and chipped (Figure 1); and
- The bricks having been "sanded down" at some point and have lost their protective finish and are therefore susceptible to absorbing water and cracking during the freeze/thaw cycle.

Figures 1 & 2: Dismantled bricks and replacement samples.

While it was expected that a certain degree of bricks would be unsuitable for restoration, we unfortunately found that the condition of the bricks was significantly worse than expected. Specifically, most of the bricks had the face ground off in a poor attempt to clean them. Many of the bricks had the backs hammered off to lay around the posts and beams. As such, it is our professional opinion that the vast majority of the bricks are not suitable for restoration and recreating a brick facade would require new bricks.

Unfortunately, he predicts that the bricks would need to be replaced at upwards of 100%. Consequently, Bryan sourced sample replacement bricks (Figure 2), which are appropriate in terms of their size, composition, design and colour. Janette Leroux and Davin Johnson (Owners) are disappointed that the historic brick veneer cannot be rebuilt using the original brickwork and are concerned that the replacement bricks will look overtly new and that the new wall will be visually abrasive in the streetscape. Moreover, the construction activities have revealed additional information about the original appearance of the house, including evidence of what is believed to be the original wooden clapboard siding, original corner trim

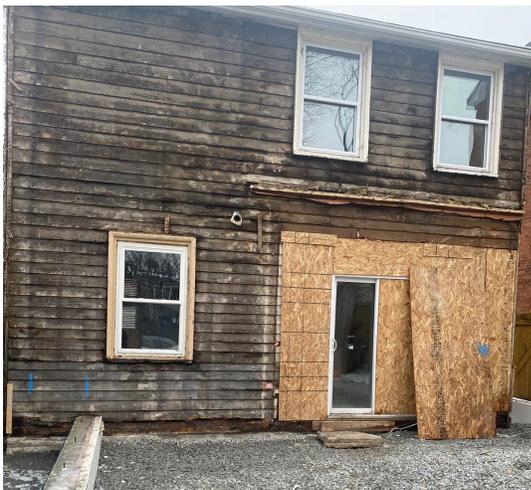
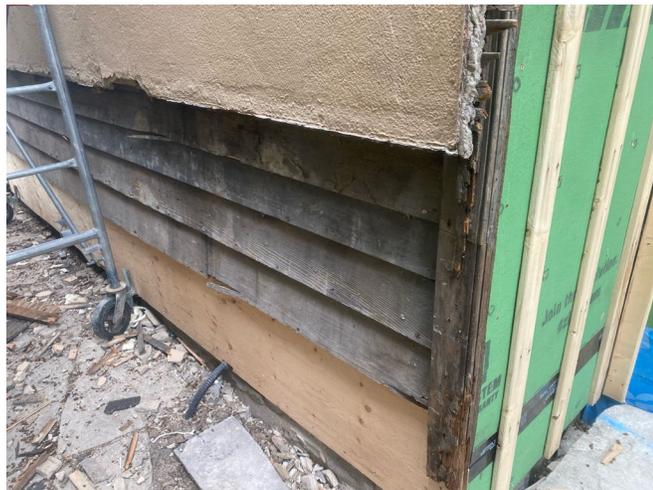
Figures 3 & 4: What is believed to be the original wooden clapboard (rear elevation) and corner trim.

During the removal of bricks, we were able to conclusively determine that the entire house was originally clad in wood siding, much of which is still present on the house today (hand-wrought nails and nail holes were evident where the siding had been removed to add the brick veneer at the front of the house). We feel that replicating the wood siding is a more appropriate building material. Using wood siding will still require some repair of the front foundation but much less so than if bricks are to be used.

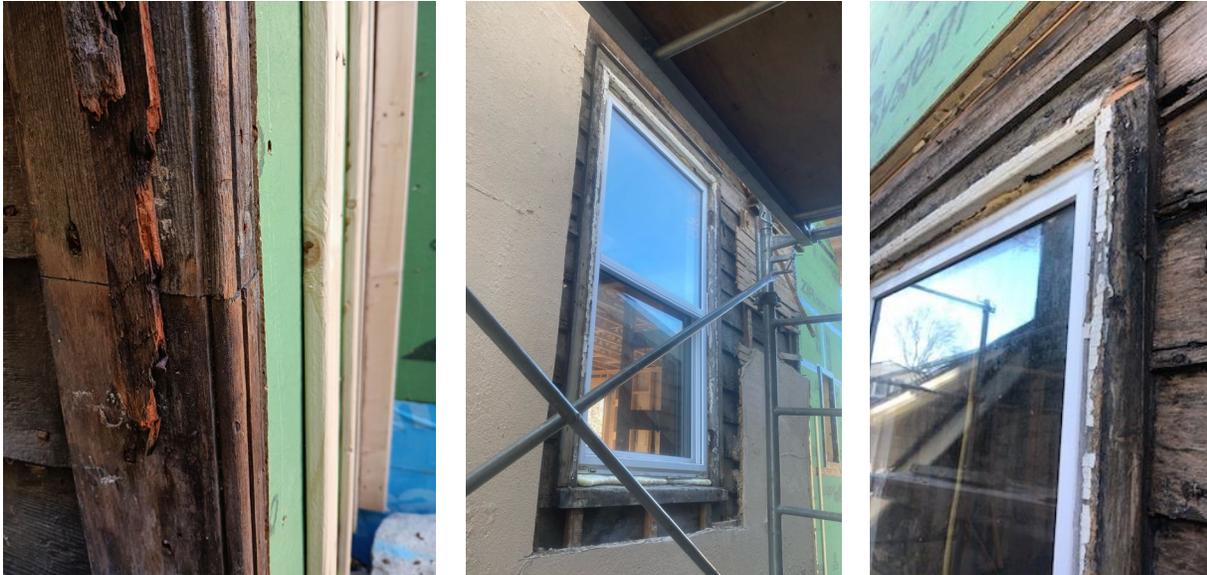
Figures 5, 6 & 7: Detail of original corner trim (note the new piece scarfed into match) and original window trim exposed showing bead detail and small drip moulding.

The corner trim is relatively plain but has a small bead detail (Figure 5). The exposed original window trim (Figure 7) is also simple with a bead detail. Cumulatively, these details confirm the existing thinking that the house's design was relatively humble.

Section 4.3.3 addresses decorative trim and details and their conservation. Given that original elements have been discovered, such as the corner boards and window trim, they will be used as a template to create replacement elements for the original portion of the house, which complies with these policies. Moreover, the selected colour scheme will be “complementary to the age, style and detailing of the building.”
